**REHABILITATION OF AN OPEN  
DUMPS IN GLIWICE POLAND**

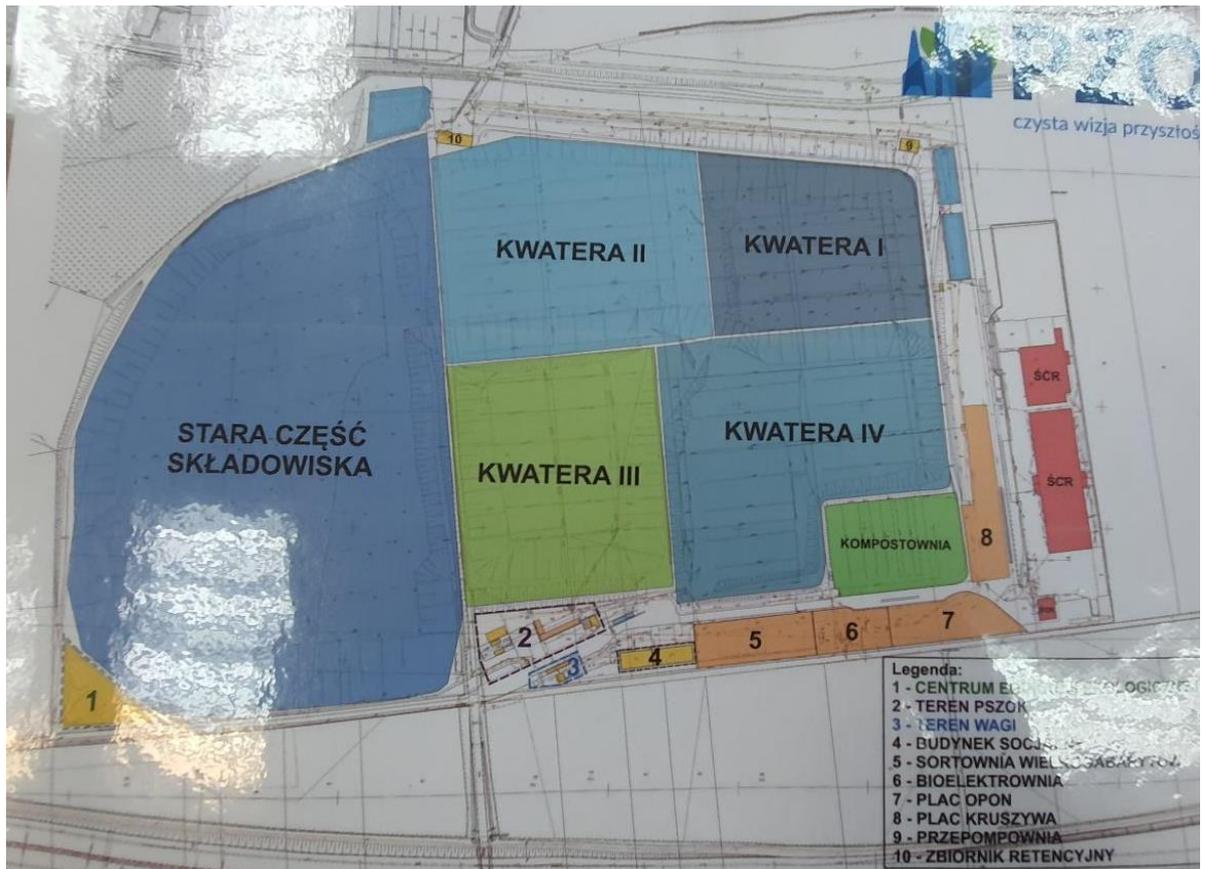
Figure 3. Scheme of the open dumps [Source: PZO Gliwice].

The open dumps currently have 4 open quarters and a closed part of the open dumps. The layout of the repository is presented in Fig. 3. Point 1 shows the part that is currently under development, the Ecological Education Center is being built in this area. The investment is already underway, the first construction machines have already entered this area. The diagram shows the drainage, drainage and degassing system (Fig. 4.).

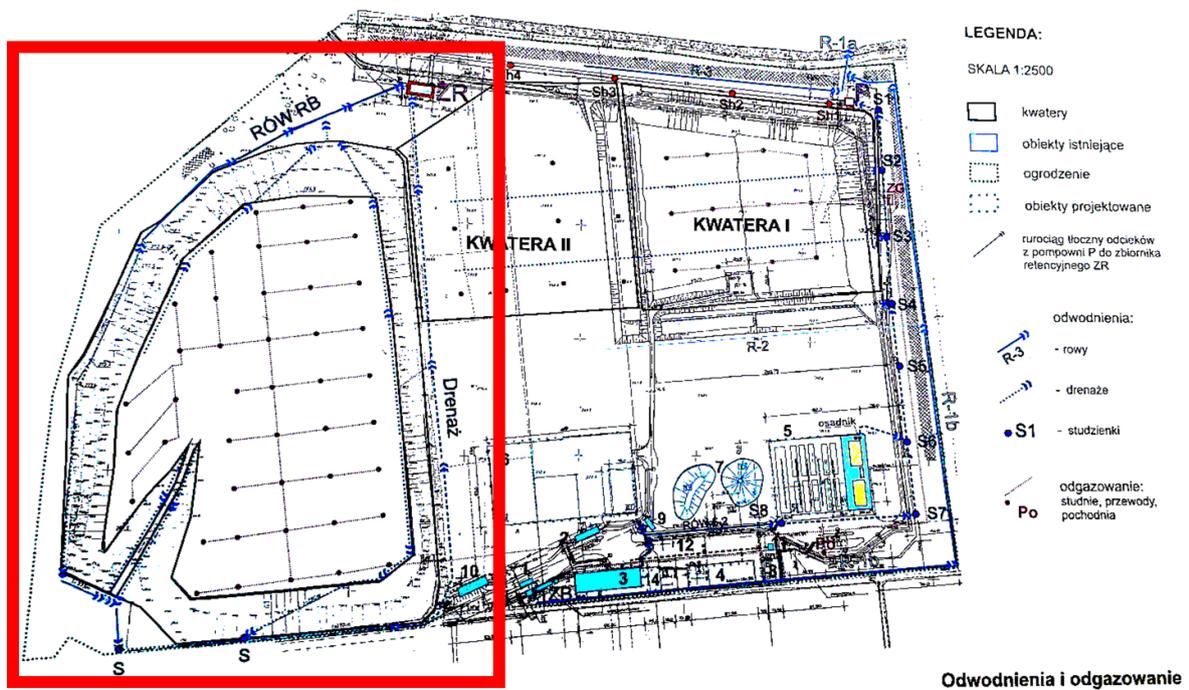
Fig. 4. Scheme of the open dumps with drainage markings and a drainage and degassing system [1].

To protect the open dumps and uncontrolled leakage of leachate into the environment, a double protection was used in the form of drainage surrounding the open dumps and a ditch on the surface led over the drainage, which also covers the open dumps. The leachate from both safeguards is collected into a retention tank, where it can be redirected further in a controlled manner.

The band drainage, consisting of two threads (a and b), was made of 100 mm diameter PEHD pipes, laid in a 4-8 mm sand back, surrounded by a 300 g/m<sup>2</sup> non-woven fabric. The total length of the drainage is 763 m (448 m for line a, 315 m for line b), and they are run along the eastern and northern part of the slopes of the open dumps.

Drainage ditches were made mainly for rainwater flowing from the canopy and slopes of the open dumps. They were made tight, like the drains, on a PEHD substrate. The ditches are 863 m long, including the RA 628 m ditch, and the RB 235 m ditch. In some places, the routes of the ditches overlap with the drainages. The entire bottom was secured with paving slabs, while the slopes were reinforced with PA azur slabs.

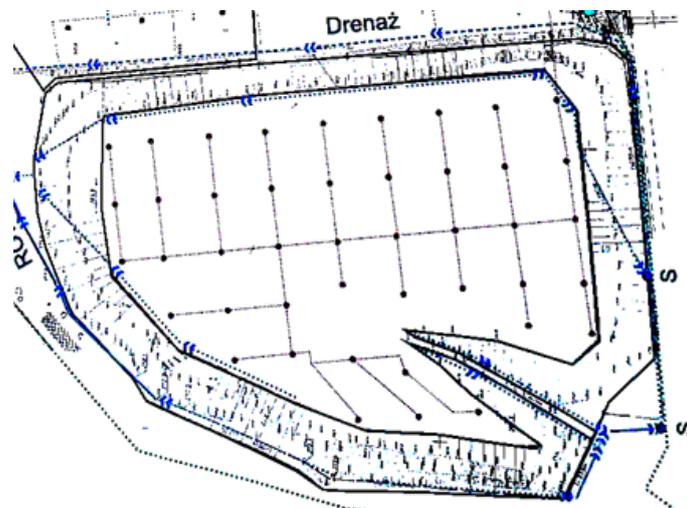
Figure 10. Scheme of degassing points of the open dumps (view from the west side) [1].

The first stage of reclamation was degassing the open dumps. The process started in 2001. Appropriate openings and an installation for degassing the open dumps gas have been made. The scheme of degassing points is shown in Figure 10. The gas discharged through vertical pipelines was used in a power generator and partially burned in a flare. This stage was completed in 2005, when the amount of biogas was so low that it was not justified to continue the degassing process.

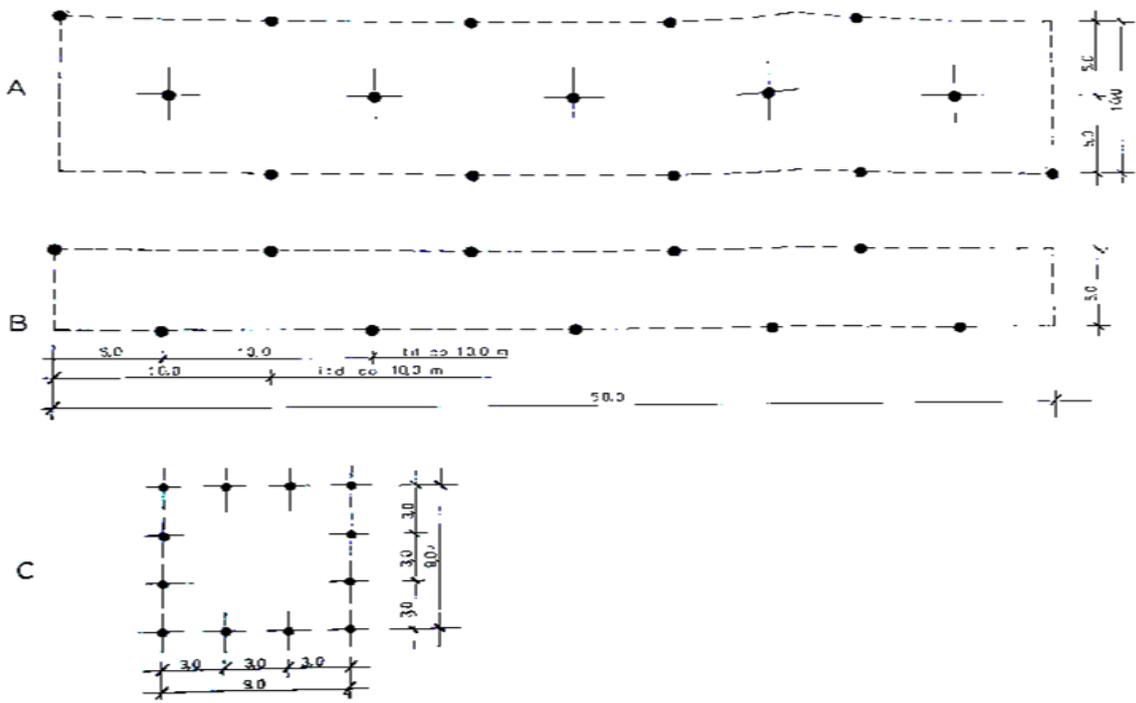
Figure 11. The scheme of plantings in the open dumps area [1].

The last layer of the open dumps protection (plateau) is soil 0.3 m high, covered with planting of bushes in the form of one species of clumps. This is to prevent wind erosion and improve the aesthetics of the site.

The slope of the open dumps and drainage were covered with grasses, and trees in strips were planted between the fence and the slope of the open dumps (Fig. 8.1). The open dumps use 3 types

of biological development area - A, B high greenery, C low greenery and grass. The following tree and shrub species were selected for reclamation:

- Trees:
  - Robinia pseudoacacia
  - Norway maple
  - Common government
  - White poplar
  - Silver birch
- Shrubs:
  - Common privet
  - Jasminowiec free
  - Bird cherry
  - Wild rose

The planting distribution is shown in Figure 11.

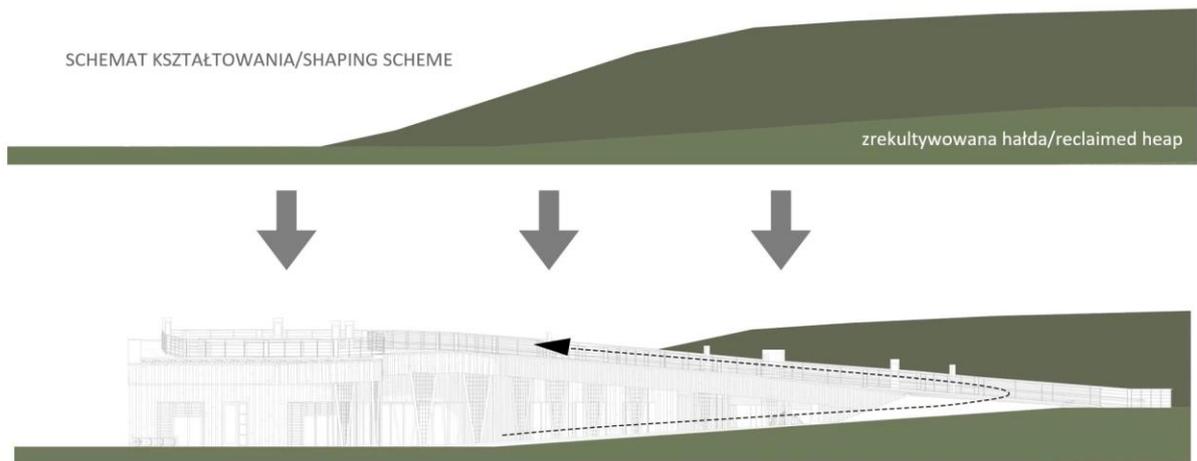
Figure 20. Diagram of the roof of the Ecological Education Center building and its location within the closed open dumps [4].

Zielony dach przystosowany do ruchu pieszych, który kształtem wpisuje się do zrekultywowanej hałdy  
*The green roof is adapted to pedestrian traffic and its shape fits into the reclaimed heap*

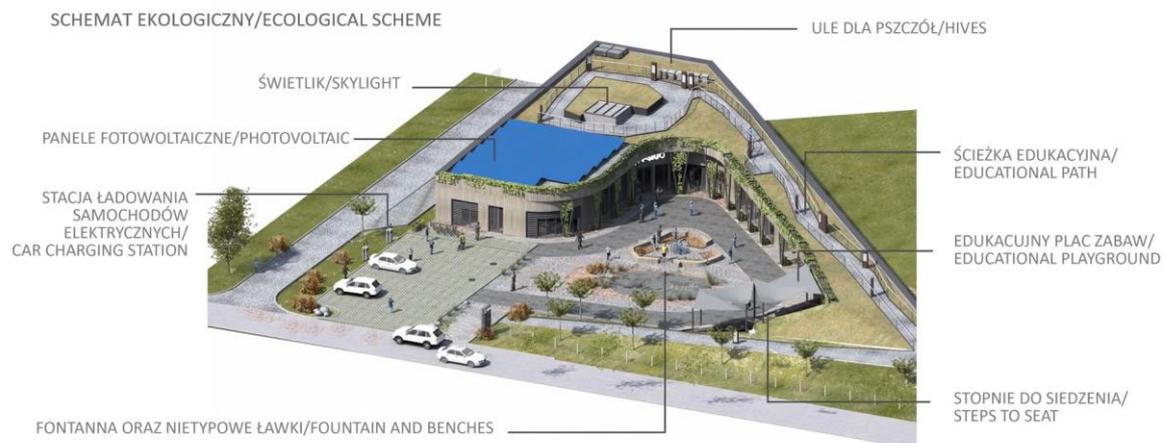
Figure 22. The overall plan of the Ecological Education Center [4].

*Ścieżka edukacyjna, instalacje fotowoltaiczne oraz ule dla pszczół powstały w trosce o środowisko  
Educational path, photovoltaic installations and beehives were created out of concern for the environment*
