THE LANDFILL OF MONTESCHIANTELLO IN FANO (ITALY) REHABILITATION AND POST-OPERATIVE MANAGEMENT OF “BASIN 1”**1. Introduction**

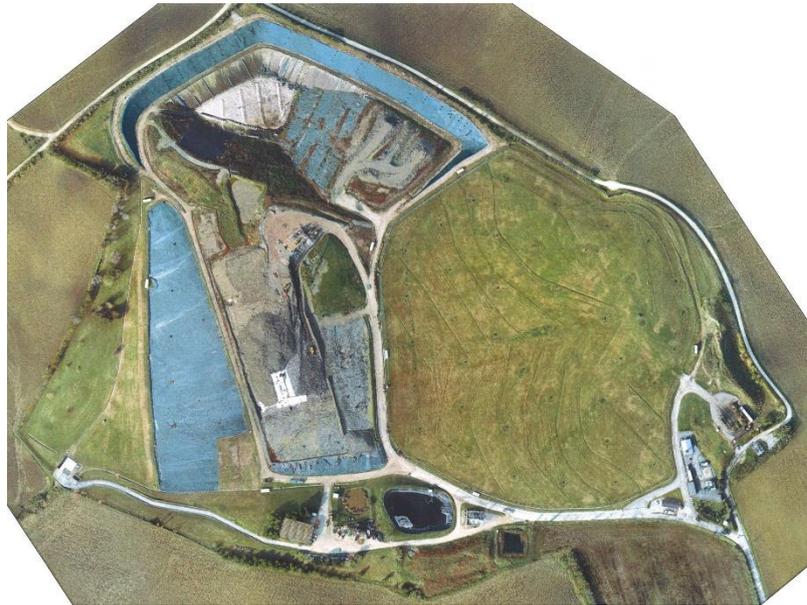
Figure 2. Aerial photo of the Landfill of Monteschiattello. Source: ASET Spa,2021

Figure 1 indicates the position of the landfill on the map in Fano (Central Italy), while Figure 2 shows an aerial photo of the dumpsite.

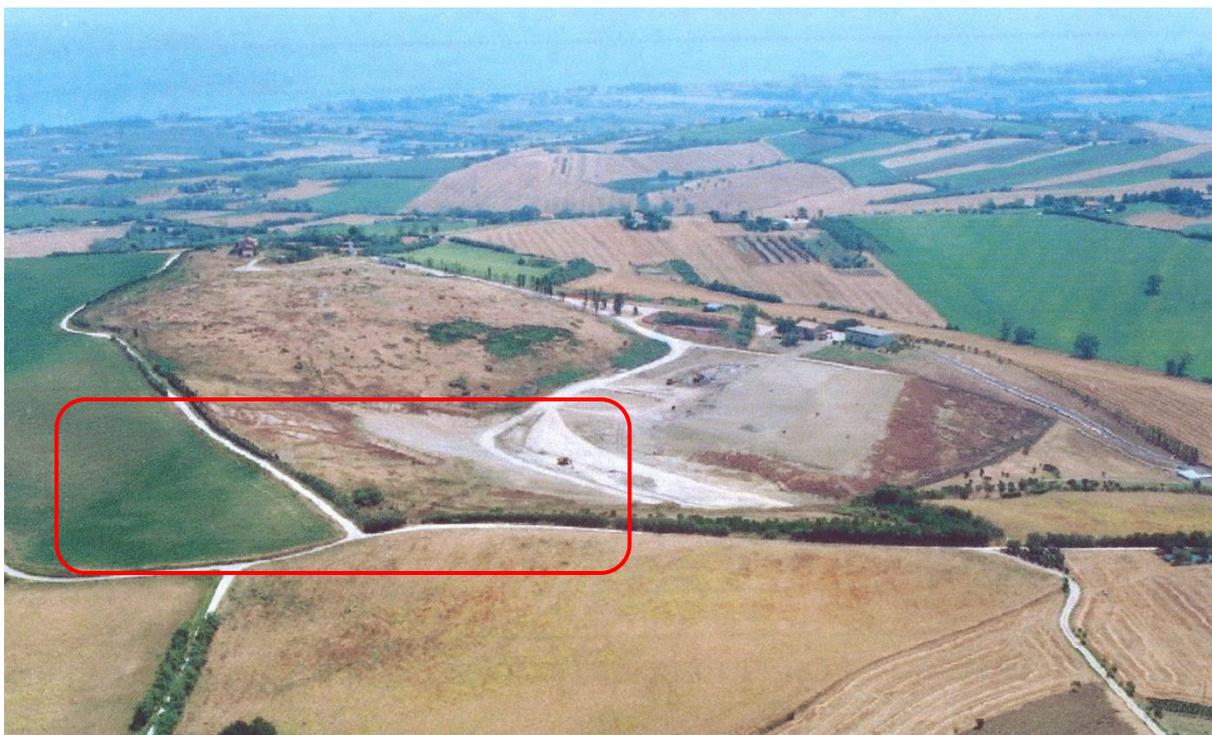
Figure 3. The landfill of Monteschiantello (Basin 1 circled in red). Source: ASET Spa, 1996.

Goelectric and geometric surveys on the area showed that Basin 1 received over 1'500'000 tons of different urban and industrial wastes produced by human activities of the territory. The following is an aerial photo of the Monteschiantello landfill back in 1996

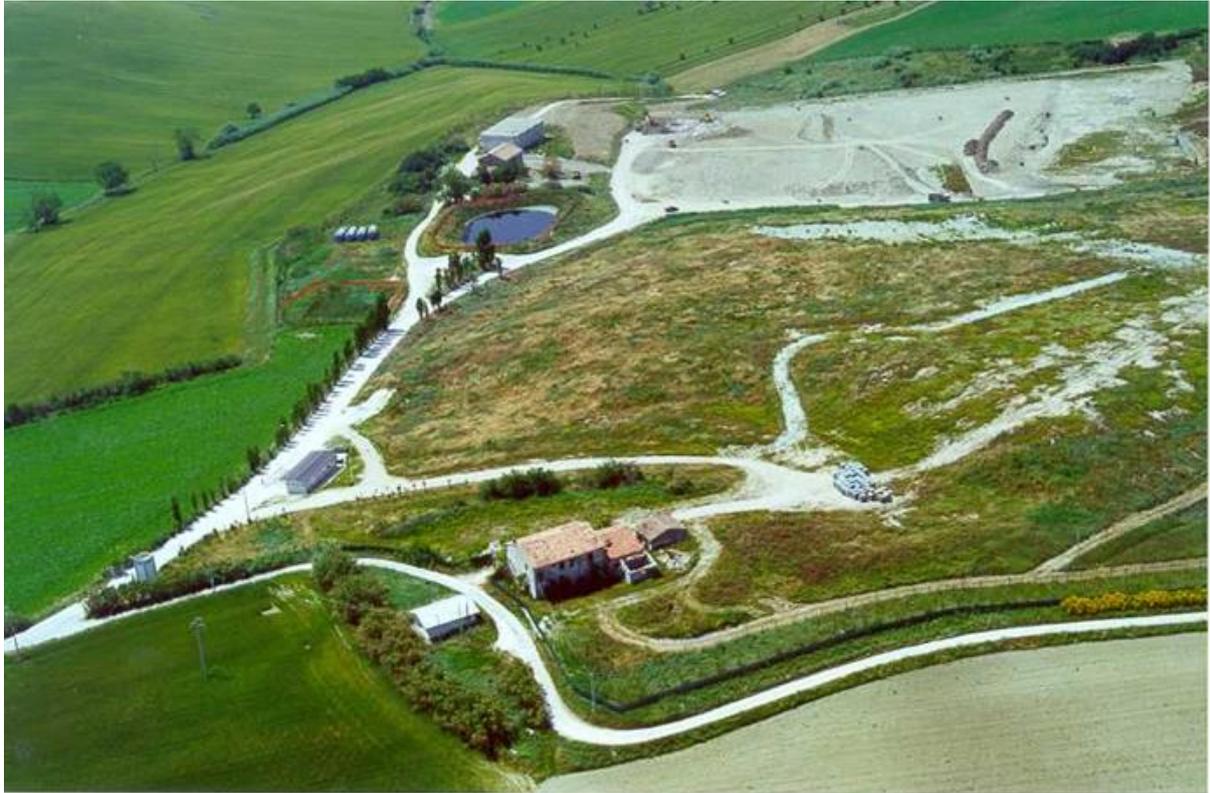
Figure 10. Basin 1 – Initial stages of the landfill Environmental restoration plan. Source: ASET Spa,2003.

The images below compare the initial and final situation of the Landfill of Monteschiantello (Figure 10 and 11).

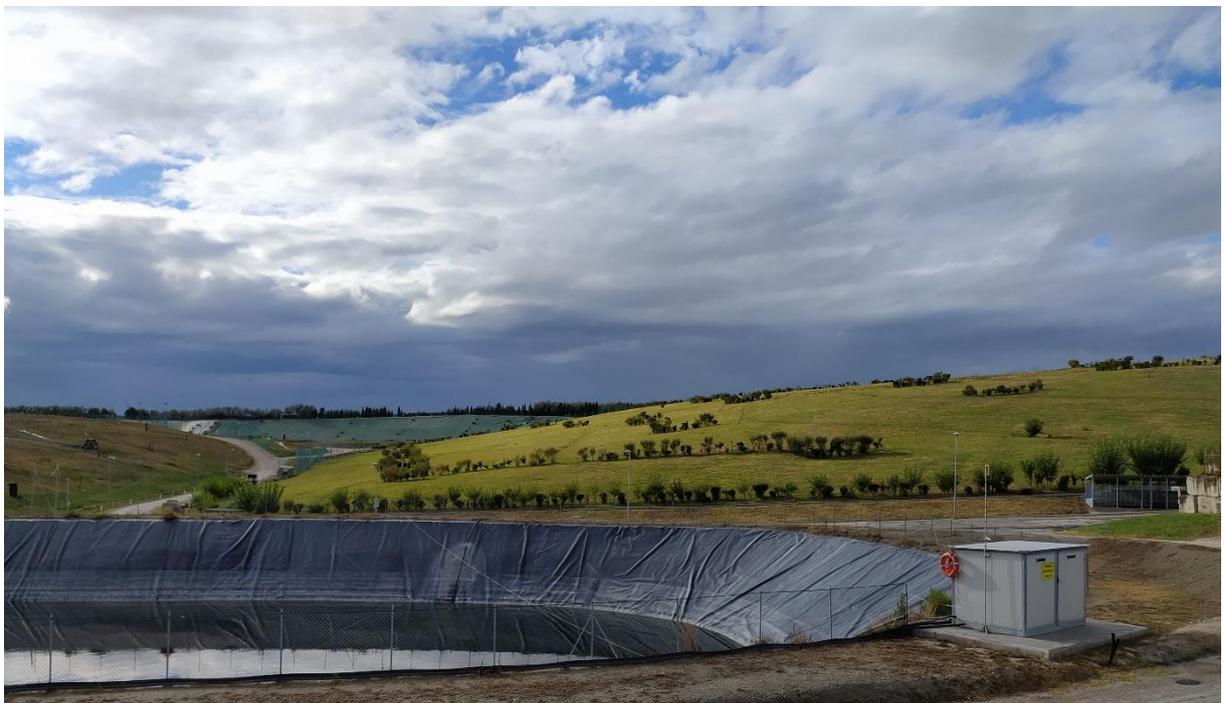
Figure 11. Basin 1- Final stage of the Environmental restoration plan. Source: ASET Spa, 2011.
