CASE STUDY

REHABILITAION OF AN OPEN DUMPS IN SARAYKÖY DENİZLİ

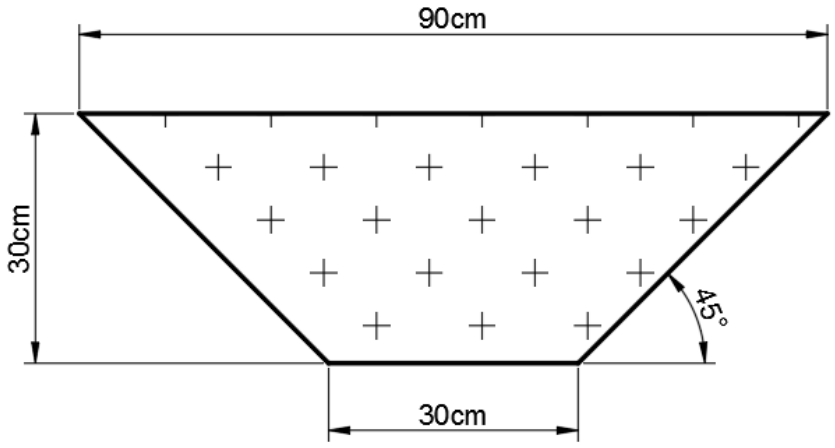
Figure 5. Surface water channel section

The dry stream bed that runs parallel to the field performs natural precipitation drainage. The 3% slope given in the surface leveling ensures the flow of precipitation falling on the surface to this dry stream bed. Trapezoidal rainwater collection channels were created outside the bank surrounding the site to collect the precipitation falling into these basins. Thus, the precipitation waters that made their way to the waste mass from the stream bed were drained by circulating the site. Open channels with trapezoidal sections mostly aim to remove the water directed at the waste mass from outside. The cross-section of the surface water channel is given in Figure 5. In addition, the drainage channel has been covered with 10 cm of concrete.
